# NATIONAL PHOTOGRAPHIC INTERPRETATION CENTER **RECONSTRUCTION ACTIVITY** **THERMAL ELECTRIC POWERPLANTS** **NORTH VIETNAM**

Attachment to N. 1775  
8 September 1969

RECONSTRUCTION ACTIVITY AT THERMAL ELECTRIC  
POWERPLANTS,  
NORTH VIETNAM

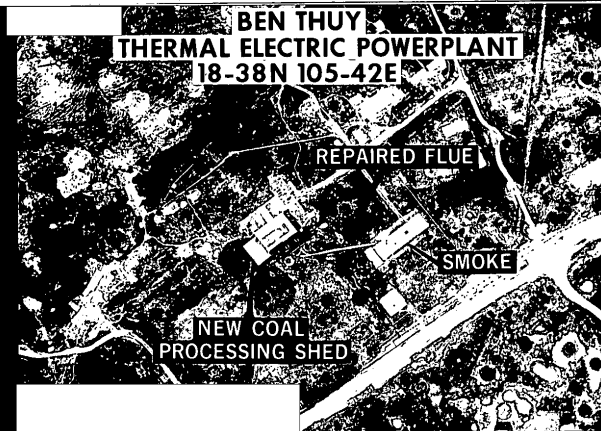
4. MISSION READOUT: [REDACTED] HAS CONFIRMED THE RESUMPTION OF OPERATIONS AT THE BEN THUY TPP. A NEW COAL PROCESSING SHED, COAL PILES, REPAIRS TO THE FLUE, AND THE ADDITION OF A NEWLY CONSTRUCTED WATER/WASTE DISPOSAL SYSTEM ARE EVIDENT. SMOKE IS OBSERVED EMANATING FROM THE TERMINUS OF THE FULE, CONFIRMING THAT THE PLANT IS IN OPERATION. THE EVIDENCE THAT ONLY TWO OF THE THREE FULES ARE CONNECTED SUGGESTS THAT THE PLANT IS OPERATING AT APPROXIMATELY TWO-THIRDS CAPACITY.

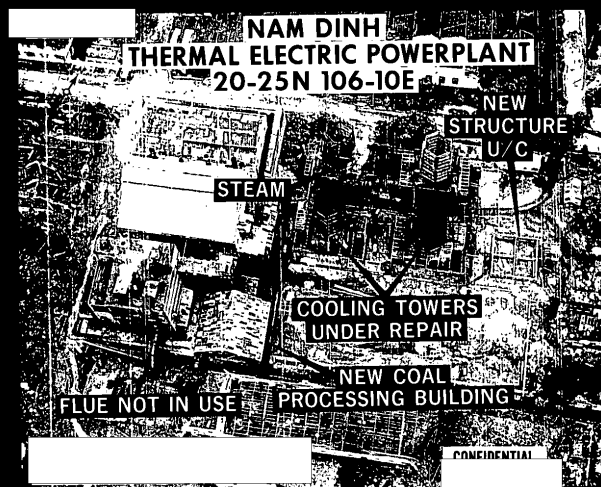
[REDACTED] REVEALS MAJOR EXTERIOR REPAIR TO THE NAM DINH TPP. PREVIOUSLY, ONLY MINOR ROOF REPAIR OR SHED CONSTRUCTION HAD BEEN OBSERVED AT ANY TPP. THE PHOTOGRAPHY REVEALS TWO OF THE FOUR HEAVILY DAMAGED COOLING TOWERS BEING REPAIRED (AND SMOKE EVIDENCES THEIR USE ALTHOUGH STILL IN A STAGE OF REPAIR), CONSTRUCTION OF A NEW COAL STORAGE AND PROCESSING BUILDING, CLEARING ACTIVITY, AND CONSTRUCTION OF A U/I STRUCTURE. REPAIRS TO THE BOILER HOUSE ROOF CONTINUE AND THE FLUE SYSTEM APPEARS INACTIVE. SMOKE IS OBSERVED EMANATING FROM BOTH THE OLD AND THE NEWER BOILER HOUSE.
